MEADOW RUN DAM

NDI ID NO. PA-00555

PHASE I INSPECTION REPORT  
NATIONAL DAM INSPECTION PROGRAM

JUNE 1980

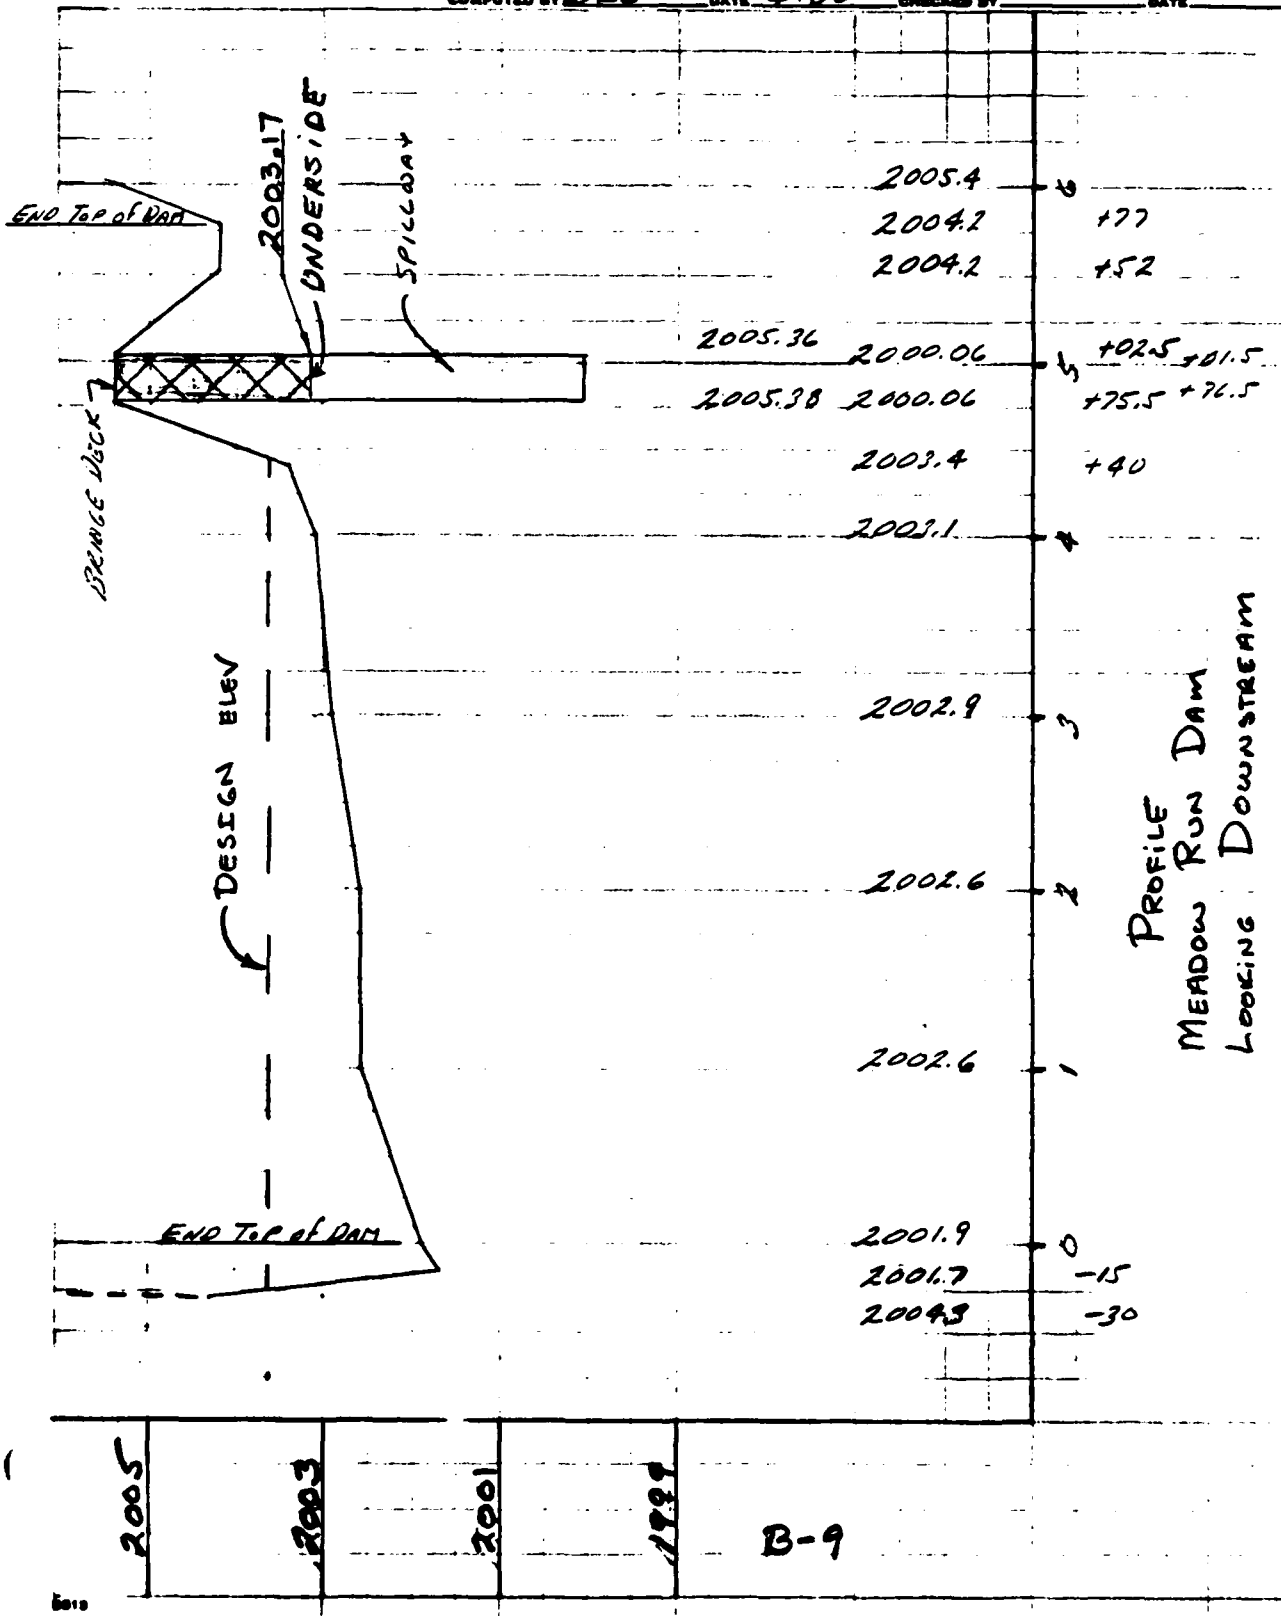
SUBJECT MEADOW RUN DAM FILE NO. 8202  
PROFILE - TOP of DAM SHEET NO. 1 OF 1 SHEETS  
FOR \_\_\_\_\_  
COMPUTED BY DRE DATE 4-80 CHECKED BY \_\_\_\_\_ DATE \_\_\_\_\_

Because of the nature of its construction, the steep downstream slope, and cracks that have developed on the top of the embankment, the stability of the embankment is considered marginal.

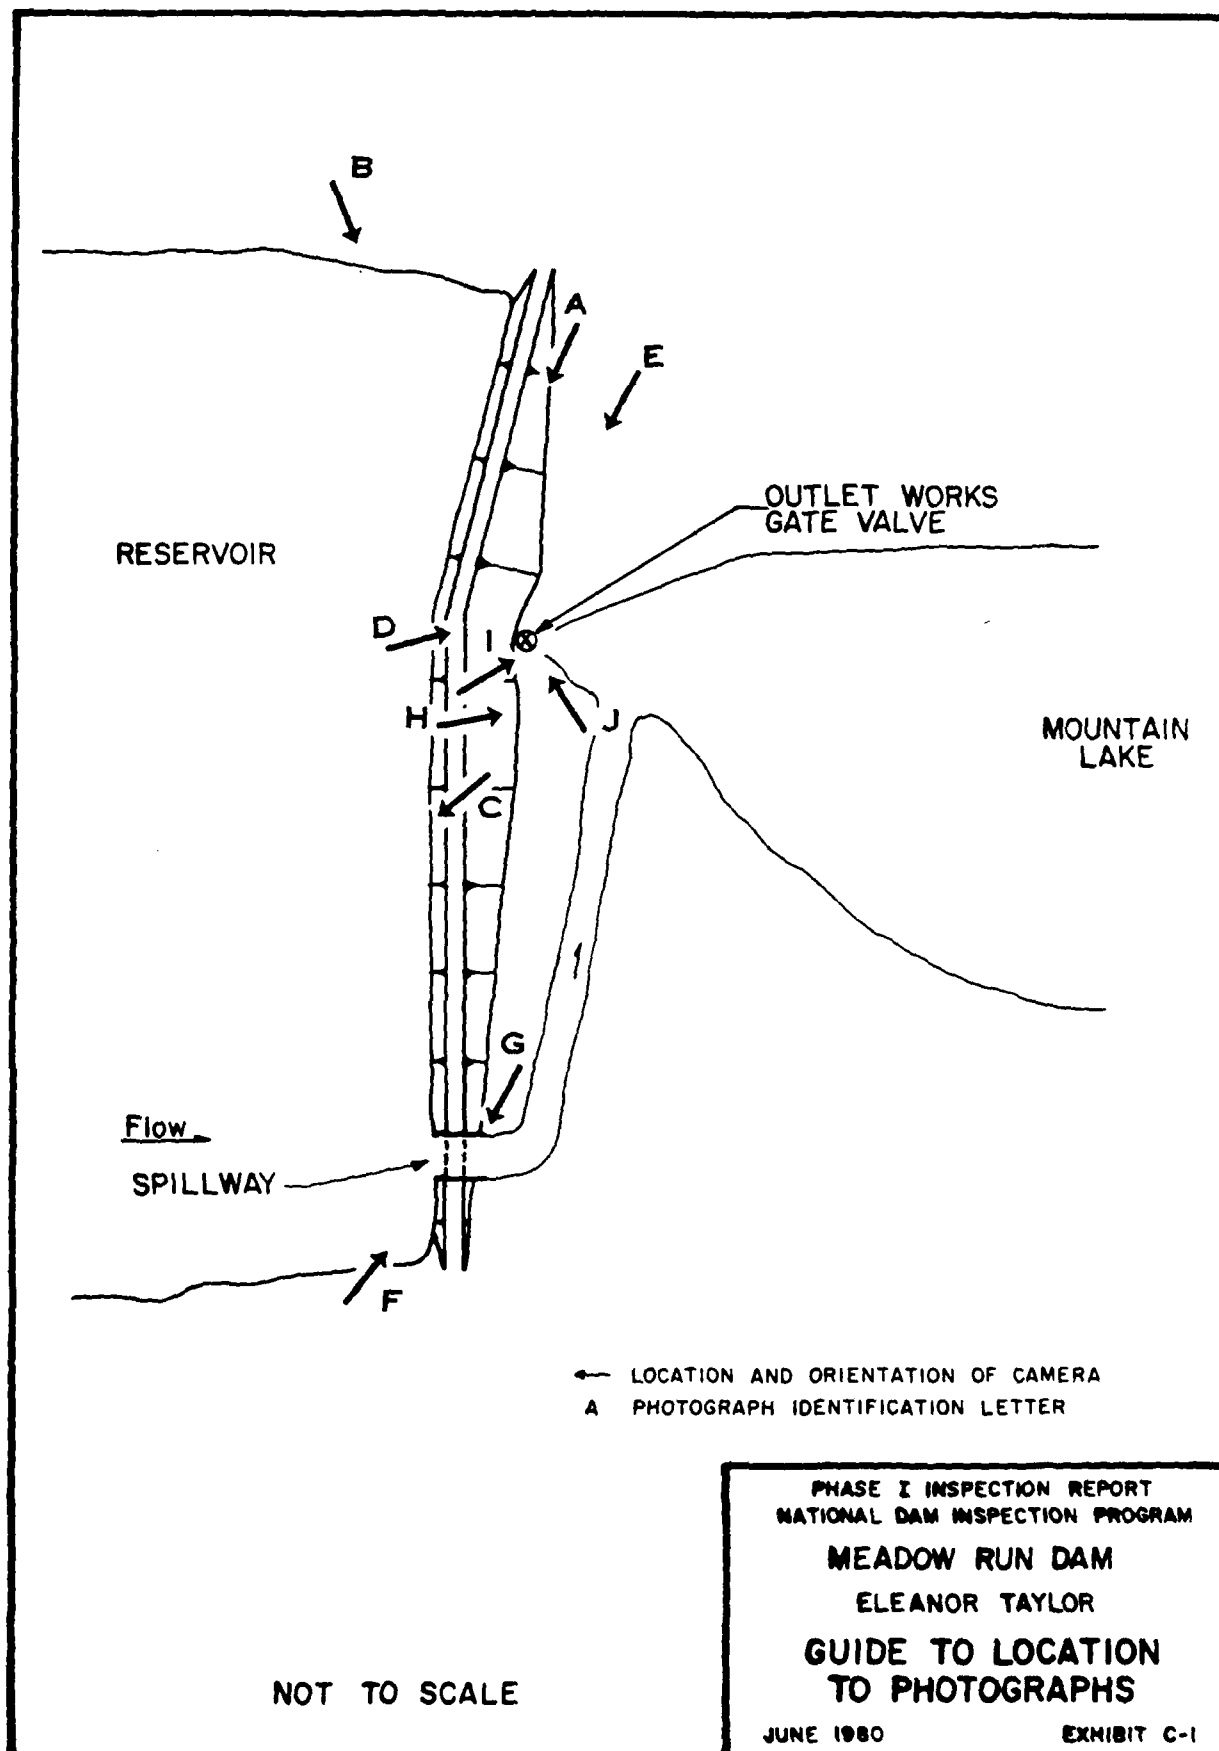
II. Outlet Works Valve

There is no evidence to suggest that the emergency drawdown facility is operational. It is in poor condition. Maintenance at the dam is inadequate.
